## PRESERVATION PLAN

## GLENBURN

BOROUGH OF RIVERDALE, NJ

**H M R** ARCHITECTS

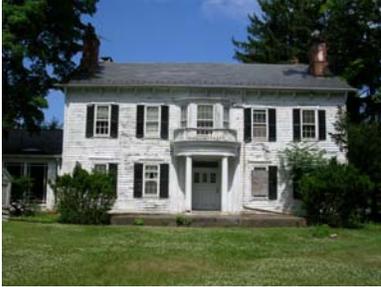
Photo 1 South Facade

Parged foundation at main block. Red concrete at addition. The rest is covered by a stone patio. The foundation appears sound.

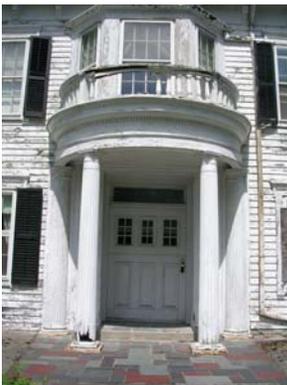
Balcony has turned balusters. Some are missing. The railing above is in poor condition. The porch has a denticulated cornice with fluted columns at front and fluted pilasters against building. Both columns have rot at the base but base of western column is in poor condition and will need to be completely rebuilt. In front of N103, there is a ventilation with grate within the concrete.

Photo 3 The balcony of the south façade dates to 1949; it is in fair condition. Many of the features likely will have to be replaced

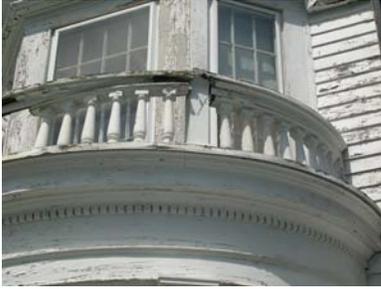
Photo 4 The balusters will need heavy repair and replacement

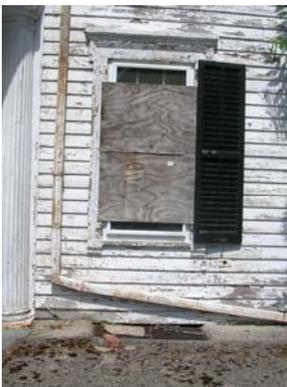
Photo 5 Window S103

Six over six with decorative head and sill but narrower than those on the north elevation. All have louvered shutters and exterior storms except S101 is missing western shutter as is S103.

S103 is boarded with missing glass underneath

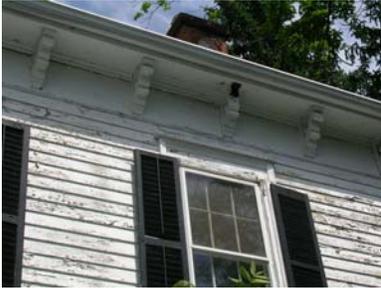
Bracketed cornice with shallow eave. One bracket is missing top scroll. The entire bracket will need to be replaced.

Photo 7 One bracket from the cornice is missing its top scroll

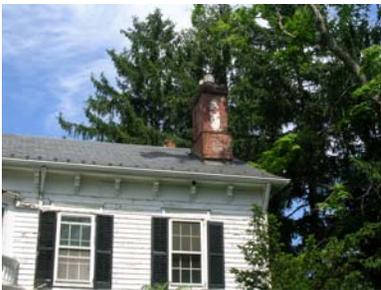
Chimneys on this side in better condition than on north. Eastern chimney is in better condition than western but has areas of efflorescence and poor pointing. Both have exposed stove pipe projecting above masonry

Photo 8 The chimneys are in fair to poor condition with areas of efflorescence and poor pointing

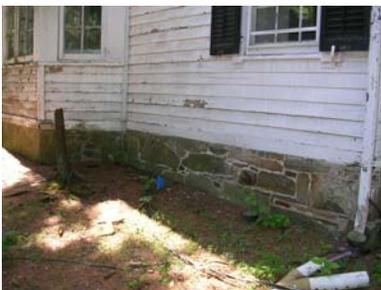
Exposed stone foundation with beautiful stonework.  
Moss on foundation at bay.

Photo 9 The foundation of the original house is visible on the east elevation

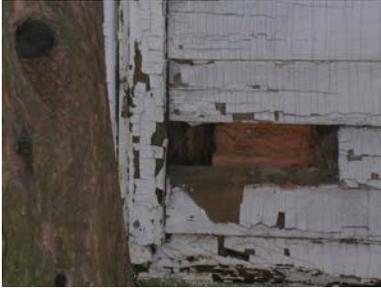
Clapboard needs paint but mostly sound. Missing clapboard at southern end shows brick nogging and deteriorated corner post

Photo 10 Brick nogging is visible under the clapboard on the east side

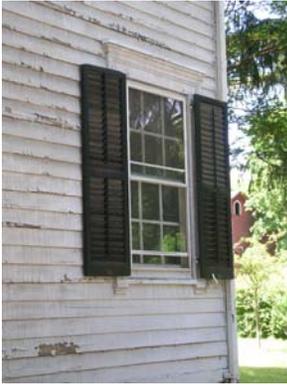
Same six-over-six with same heads and sills as south and north. Exterior storms and louvered shutters. E101 is missing north shutter

Photo 11 E103 has original decorative head and bracketed sill

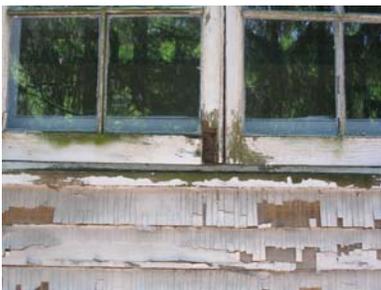
Photo 13 The bay window shows signs of deterioration with water damage and mold

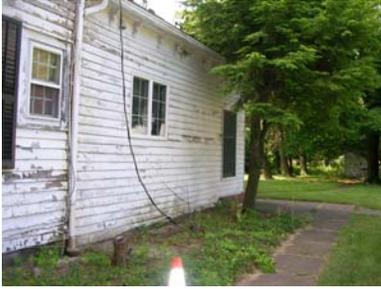
Loose clapboard to the east of the chimney with exposed insulation underneath. Although desperately in need of paint, the clapboard appears sound.

Photo 17 The one story western section likely dates to ca. 1868. It has been remodeled several times including recently when the vinyl windows were added

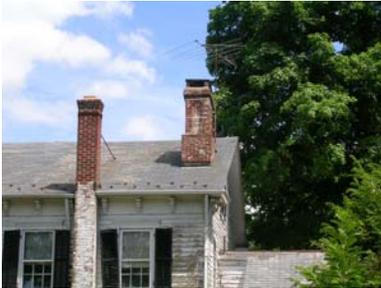
West Chimney Poor condition efflorescence spalls large antenna next to it

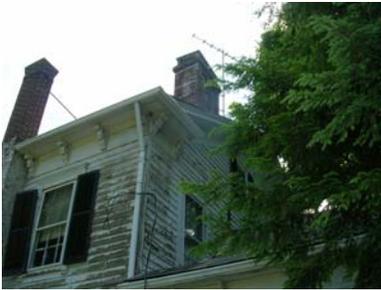
Photo 26 Northwest corner with peeling paint

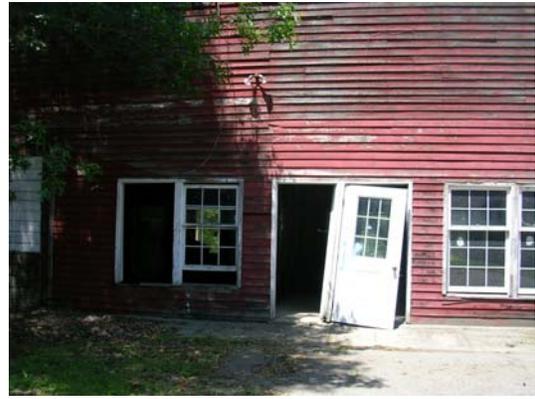
Photo 78 The threshing doors have been enclosed with new windows and doors. This will be restored
