PRESERVATION PLAN FOR  
**GLENBURN**  
RIVERDALE, NEW JERSEY

**EXISTING PLANS**

**Glenburn House and Site - Riverdale Borough, New Jersey  
Preservation Plan**

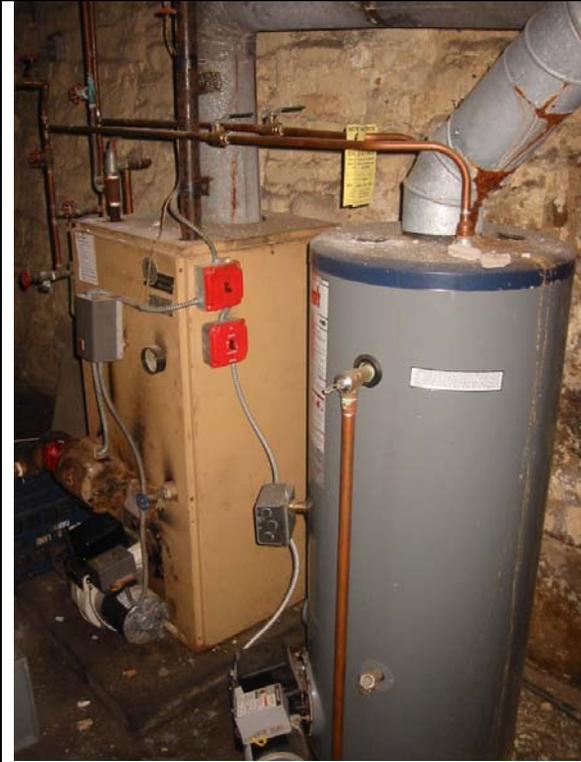
The boiler is old and in fair condition. The chimney through which the boiler vents has been added to the façade of the house and is an eyesore.

Fig. H-1- Boiler at rear of photo.

The buried oil tank should be emptied and decommissioned as soon as possible. An indoor oil tank may be provided in lieu of the outdoor tank, but replacement of the oil boiler with a gas fired unit should be considered. The boiler is old and inefficient and gas service is available.

A gas fired sealed combustion boiler is recommended for installation, such as the Weil McLain Ultra. This would allow removal of the chimney serving the existing unit and obviate the need for an oil tank. The vent piping from the new boiler must be routed to a suitable location.

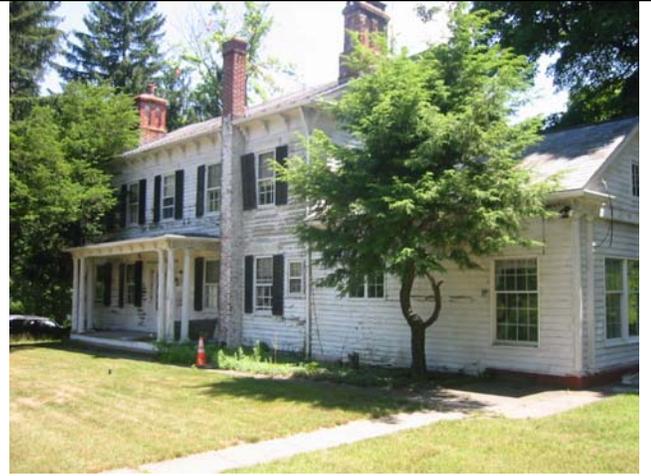
Fig. H-2- The boiler chimney is visible on the front façade.

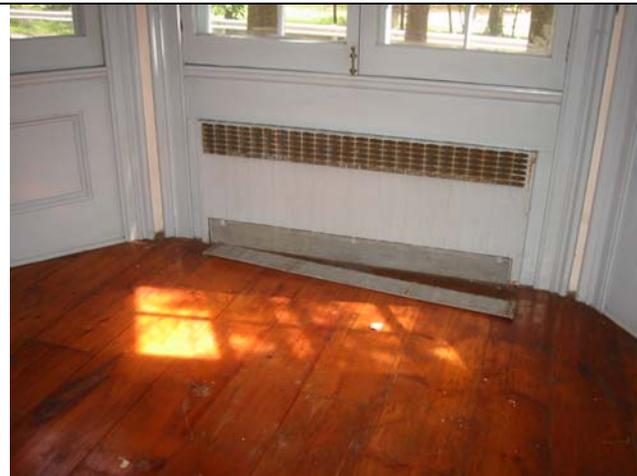
Fig. H-3- Typical cast iron convector.

The existing heating distribution system appears to be in functional condition and may be retained. The piping and radiators are of good quality and the radiator installation is well executed throughout most of the house. The system should be filled and put under pressure to check for leakage. All boiler controls and safeties must be checked by a qualified contractor.

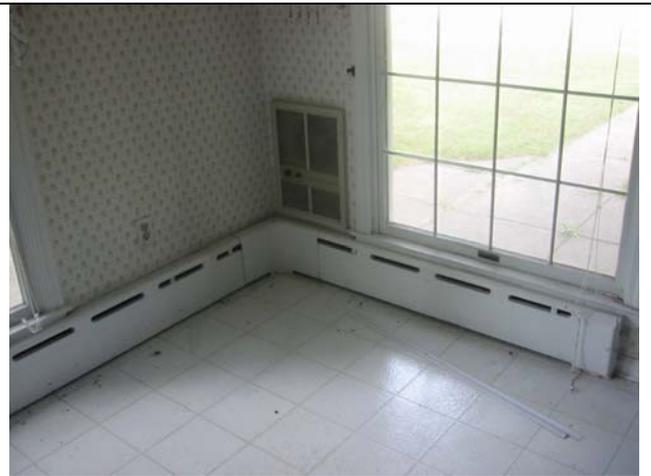
Fig. H-4- Kitchen baseboard radiator with electric heater above it.

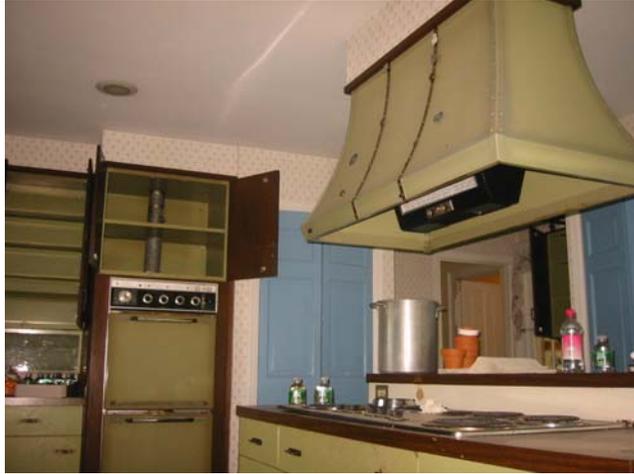
Fig. H-5- Kitchen canopy hood.

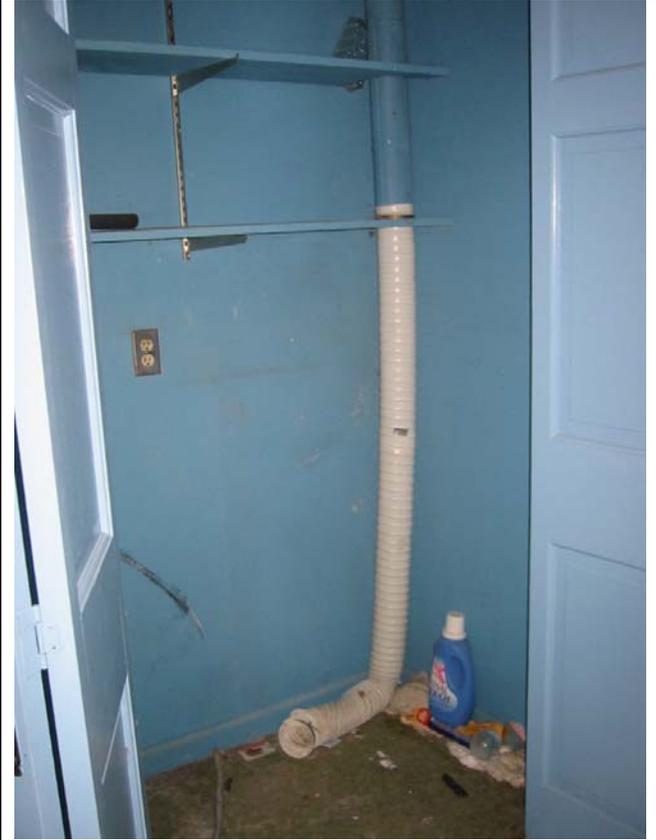
Fig. H-6- Plastic dryer hose connected to metal vent.

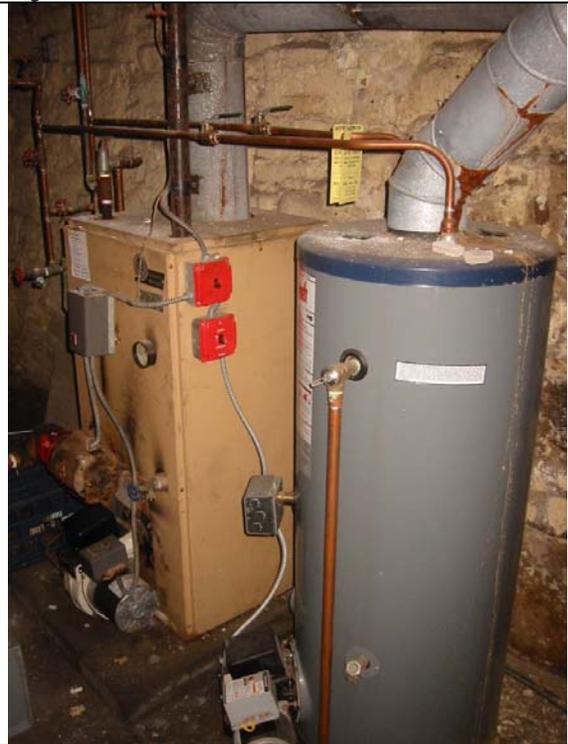
Domestic Hot Water- Hot water is provided by an oil fired water heater located in the basement adjacent to the boiler (*Fig. P-4*). The heater flue discharges into the same chimney as the boiler. The heater is a Bock Model 32E, 32 gallon storage, 102 gph recovery. The burner is a Bock Model MSR with a range of 0.5 to 2.75 gph #2 oil. The hot water system has no circulating pump. This water heater serves all the fixtures requiring hot water in the building.

Domestic Hot Water- The piping appears to be in good condition. Water heater is fairly new and appears to be in good condition. A stated goal of the project, however, is to remove the chimney used by this heater.

Fig. P-4- Domestic water heater.

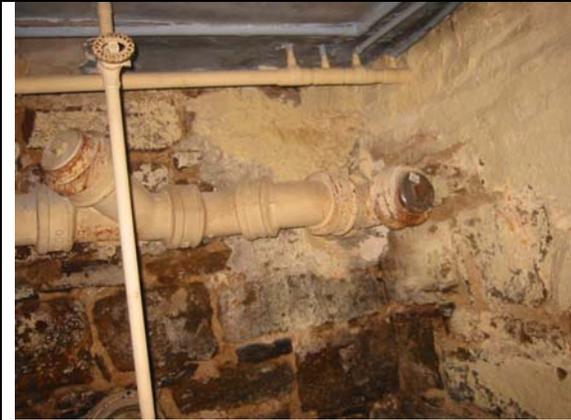
Sanitary Piping- Cast iron sanitary piping appears to be in good condition.

Fig. P-5- Sanitary Main

Sanitary Piping- Replace any worn drain traps under fixtures and upgrade lavatory waste and water piping to comply with ADA regulations as required. Repair or replace piping at leaks as needed. The sanitary main should be

internally inspected to assess its condition and the septic system evaluated for condition and capacity for expected occupancy.

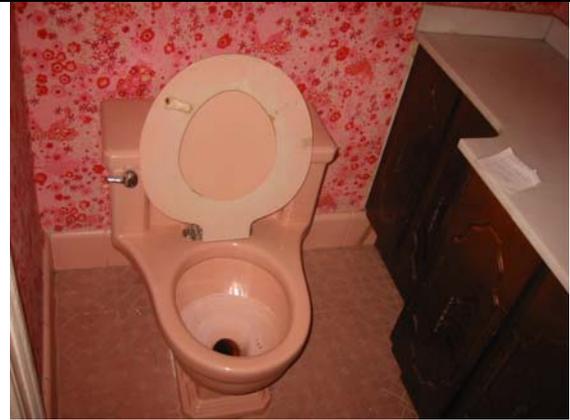
Plumbing Fixtures- Toilet fixtures appear to be of good quality and in good condition. However, they are not compliant with current code since they are not low flow type, nor are they ADA compliant. Kitchen fixtures appear to be in good condition.

Fig. P-6- Typical water closet

Plumbing Fixtures- Replacement of plumbing fixtures with low flow type is recommended. Provide new ADA fixtures as required. Fixtures in the attic should be removed and piping capped at main.

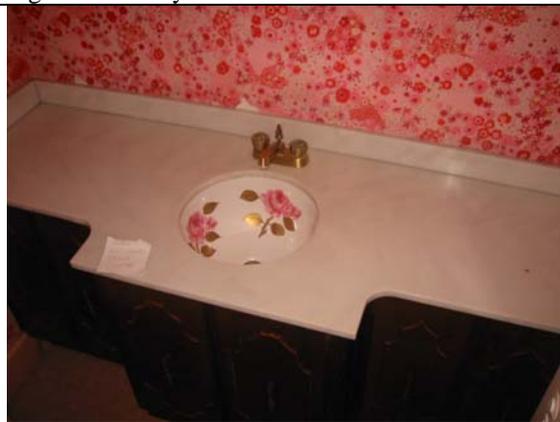
Fig. P-7- Lavatory

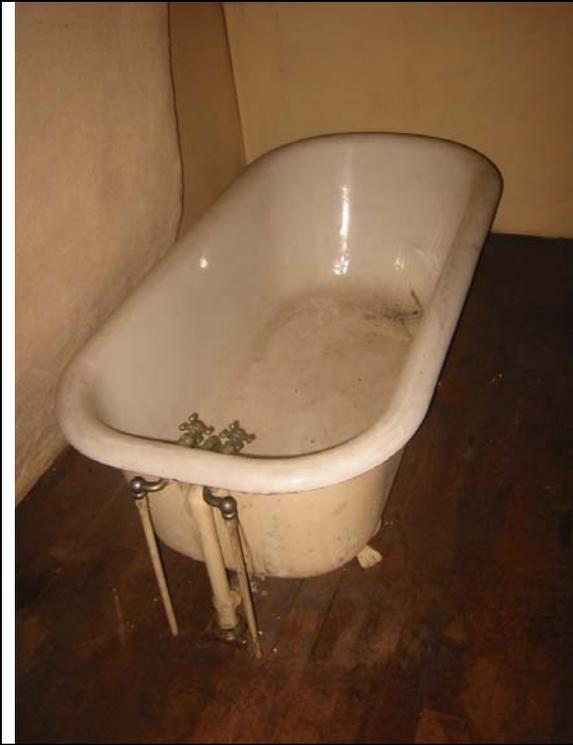
Fig. P-9- Tub in attic.

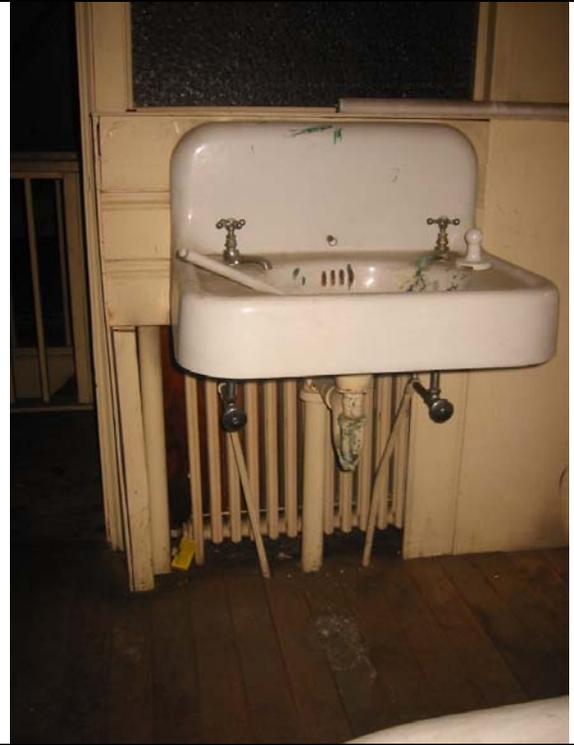
Fig. P-10- Sink in attic.

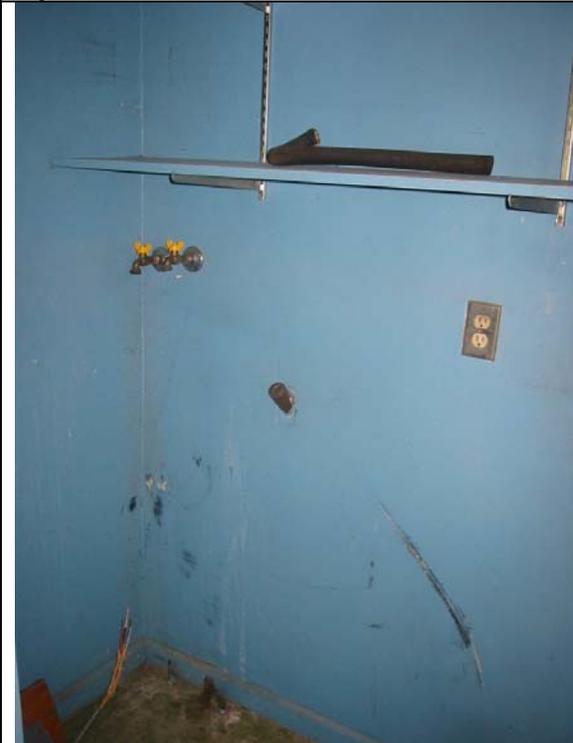
Plumbing Fixtures- Toilet fixtures installed in each of several bathrooms throughout the building are made of vitreous china. Water closets are floor mounted. Lavatories are wall hung and counter top. The kitchen sink is stainless steel (*Figs. P-6, P-7, P-8*). There are older fixtures in a bathroom in the attic (*Fig. P-9, P-10*). There is a hookup for a clothes washer in a closet in the kitchen (*Fig. P-11*).

Fig. P-11- Clothes washer hookup.

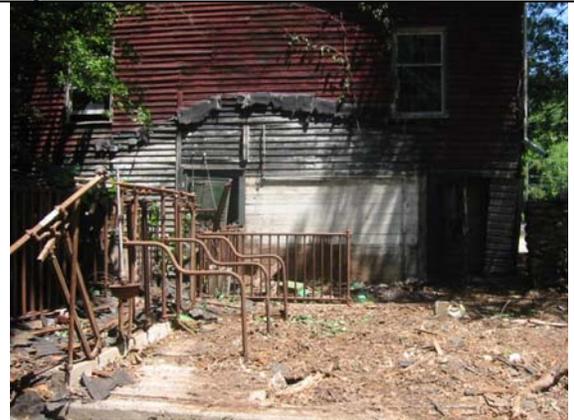
Fig. P-12- Piping is visible on the rear wall of the Barn.

General- If a bathroom and service sink are desired in the building, all new services, including water and sanitary drainage must be provided. Since the building will not be provided with year around heating, an enclosed bathroom should be provided which can be equipped with separate heating for freeze protection. All plumbing piping will enter this room directly from underground services, deep enough for freeze protection.

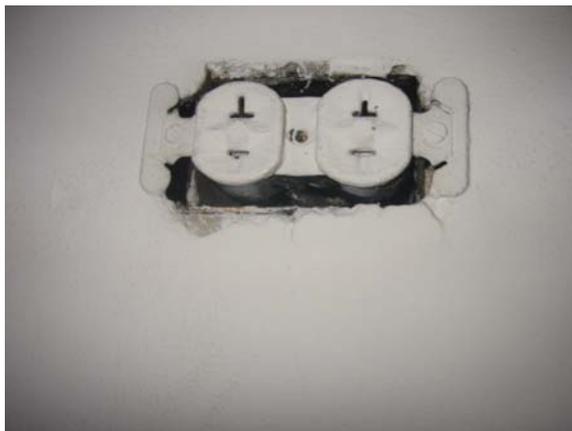
Wiring- The wiring within the panels and exposed in the basement, was generally in fair condition. There was an electrical upgrade in the past that added additional circuits to the building. These circuits powered grounded electrical outlets. It appears that the older wiring serves non-grounded receptacles (*Fig. E-3*).

Fig. E3- "Non-grounded" Receptacle

Receptacles- All non-grounded receptacles should be replaced. Ground fault circuit interrupting receptacles should be added within six feet of sinks, at the exterior of the building and in the basement.

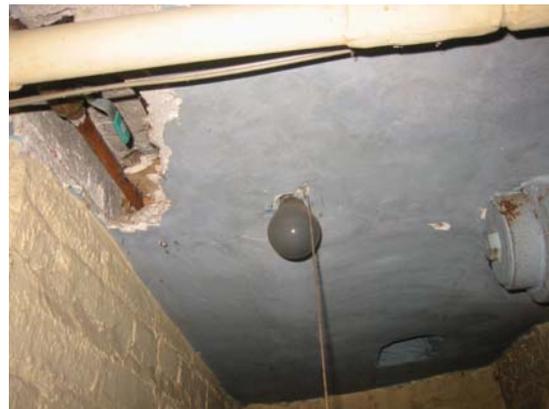
Lighting- The existing lighting consists of various, incandescent and fluorescent fixtures. A fixture in the basement has been plastered into the ceiling and is a code violation (*Fig. E-4*).

Fig. E4- Light Fixture Plastered into Ceiling

Lighting- All lighting and switches should be replaced.

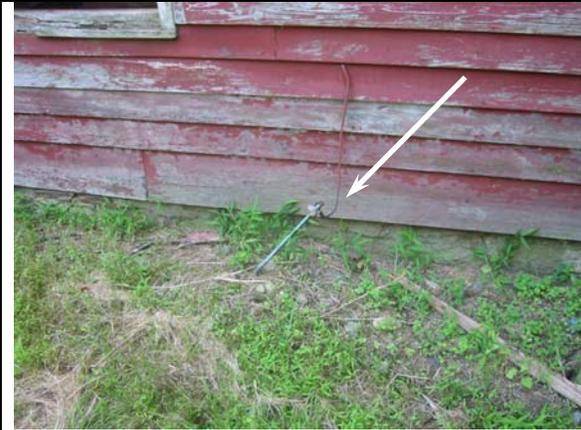
Service- There is no active electrical service to the building. The barn appears to have had it's own electrical service as evidenced by the ground rod at the exterior of the building (Fig. E-5). The main service panel board was in poor condition (Fig. E-6). The smaller branch panelboard was in worse condition (Fig. E-7).

Fig. E5 – Barn Electrical Ground Rod

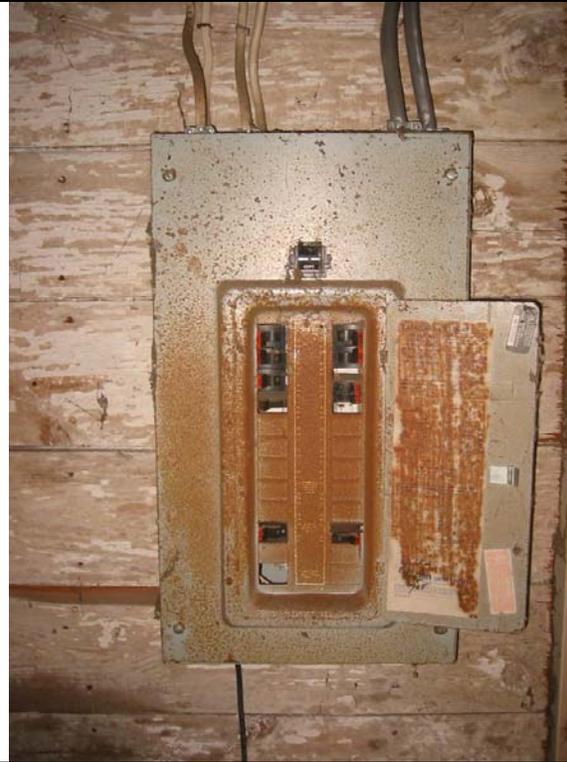
Fig. E6 – Barn Service Panel

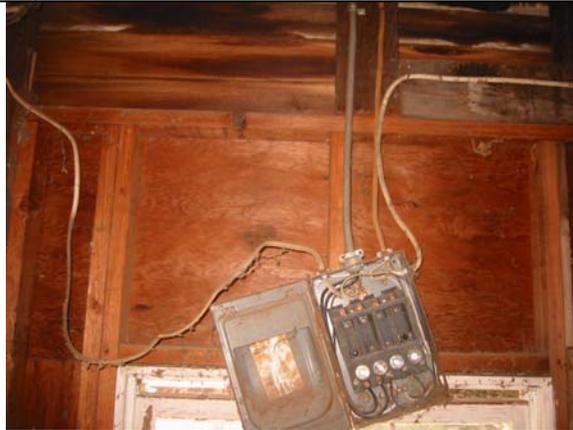
Fig. E7 – Barn Branch Panel

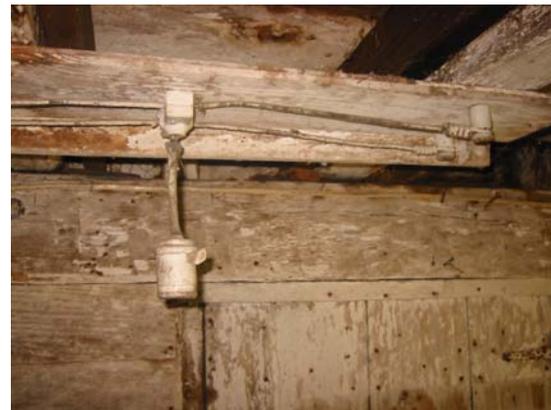
Wiring- The majority of the wiring within the building is knob and tube wiring in poor condition (Fig. E-8).

Fig. E8 – Knob and Tube Wiring

Wiring- A wiring system should be installed to meet current code. Portions of the existing knob and tube wiring should be retained in a non-functional condition for display purposes (Fig. E-10).

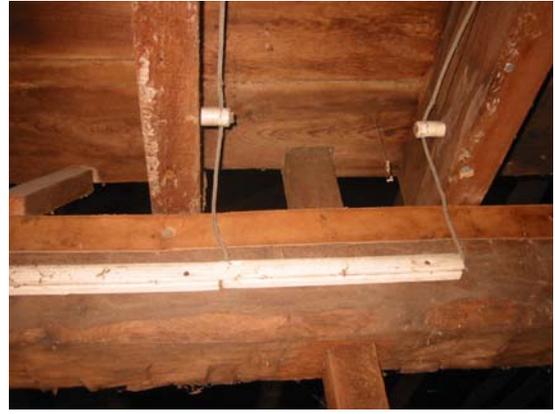
Fig. E10 – Knob and Tube Wiring and Electrical Wood-molding
