NEW JERSEY OFFICE OF CULTURAL AND ENVIRONMENTAL SERVICES
HISTORIC PRESERVATION SECTION
INDIVIDUAL STRUCTURE SURVEY FORM

HISTORIC SITES INVENTORY NO. 1433-004

RECORDED BY: Robert Guter
ORGANIZATION: ACROTHERION

DATE: March-July 1986

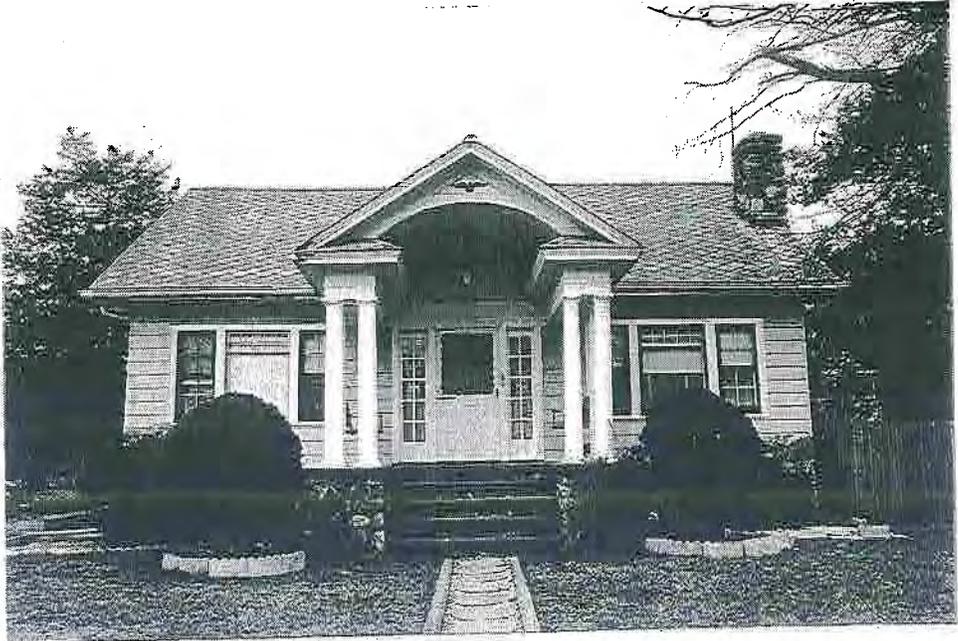
Negative File No. A7:35

Construction Date: ca. 1921-1933
Architect:
Style: Neo-classical Bungalow
Number of Stories: One
Foundation: Cemented
Exterior Wall Fabric: Synthetic siding
Fenestration: Banked multipaned sash
Roof/Chimneys: Gable with projecting eaves and exterior cobblestone chimney
Additional Architectural Description:
Distinguishing feature is gabled and barrel-arched entry portico.

This is "The Crescent", a mail-order house first advertised by Sears, Roebuck in 1921, and sold as late as 1933. This example is identical to the catalogue illustration except for the change of chimney placement, and the substitution of cobblestone for brick

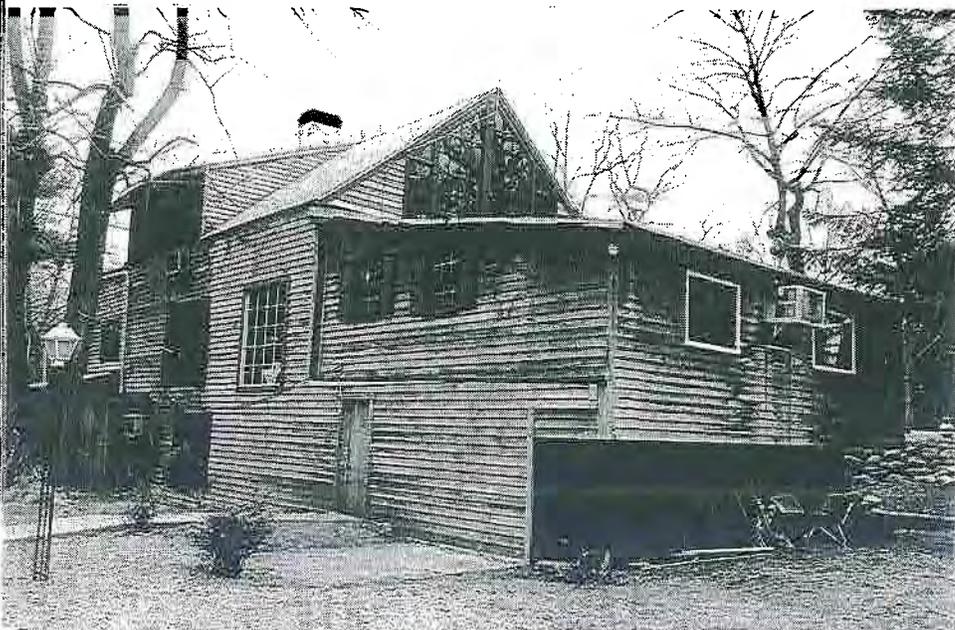
Negative File No. A7:34

As can be seen from the photograph, the only surviving exterior features of this mill are general shape and roof pitch. All siding and fenestration are altered. A good deal of the interior braced frame is intact, but the space has been sub-divided with no relation to original function.

** mill burned
Site is now
Howard Appel
Memorial Park*

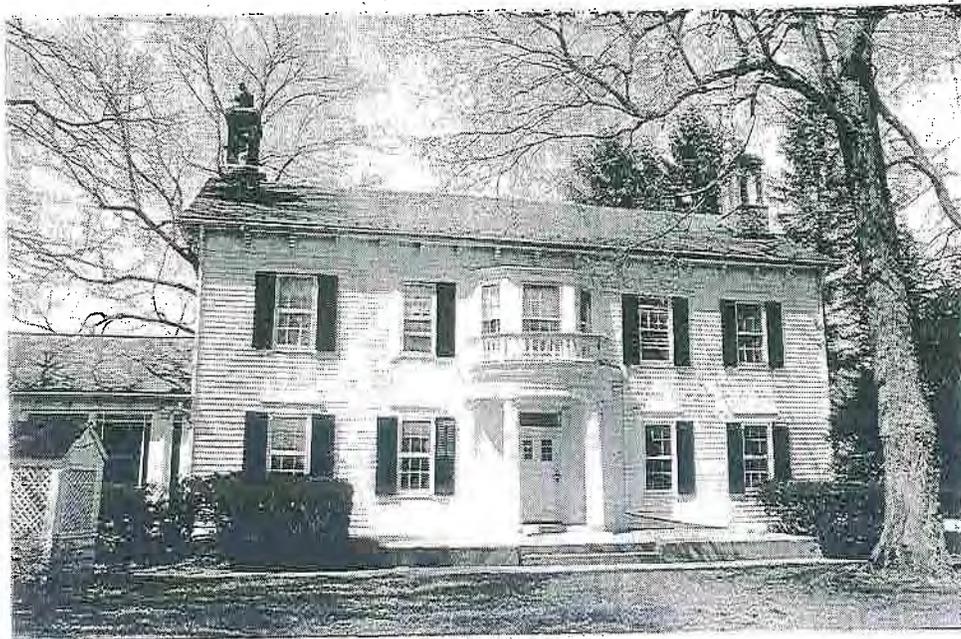
Negative File No. A7:31-33

The north west facade has Colonial Revival entry with semi-circular porch supported on four fluted Doric columns. The opposite facade porch is flat-roofed and carried on six attenuated Doric columns. The gable roof is slate covered, its molded projecting eaves and plain frieze finished with brackets.

The house stands across the road from the Van Ness Gristmill, with its gable end towards the road, situated behind a low stone wall. To the west of the house is a 1 1/2 -story frame outbuilding with L wing, which may be early 19th century (or earlier), an attached 20th century greenhouse, and a frame barn. A frame wellhouse is also extant.

The house is a good example of a Federal-derived five-bay farmhouse enlarged and updated with Italianate and Colonial Revival alterations (judging from photos in Borough of Riverdale New Jersey: 50th Anniversary Commemorative Book, the semicircular entry porch dates from after 1907). Since the Van Ness family is reputed to have owned this property and the gristmill opposite since the 18th century, part of the house may be older than 1853, when its first map appearance occurs, but there is no obvious external evidence of a three-bay side hall house enlarged. It is important for its association with the early mill and 18th-century Dutch settlement patterns locally.

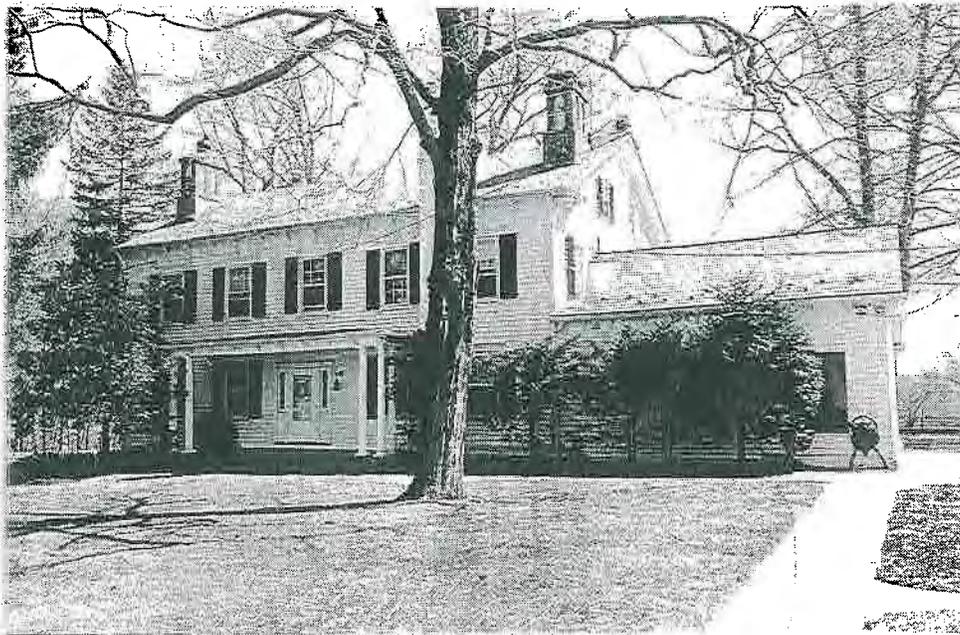
PHOTO A7:32
Present rear elevation of Van Ness House.

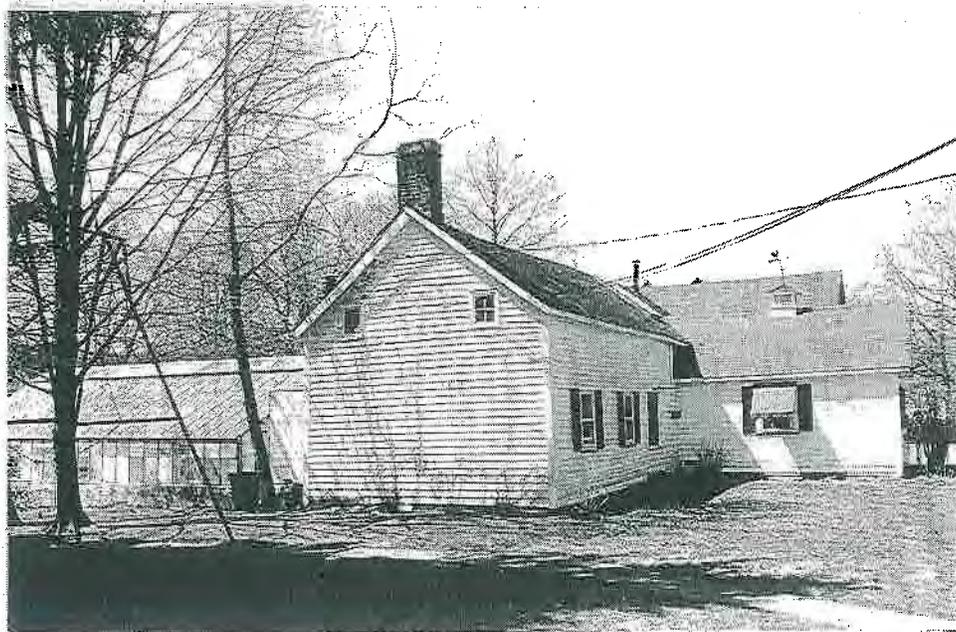
PHOTO A7:33
Van Ness House outbuildings and greenhouse.

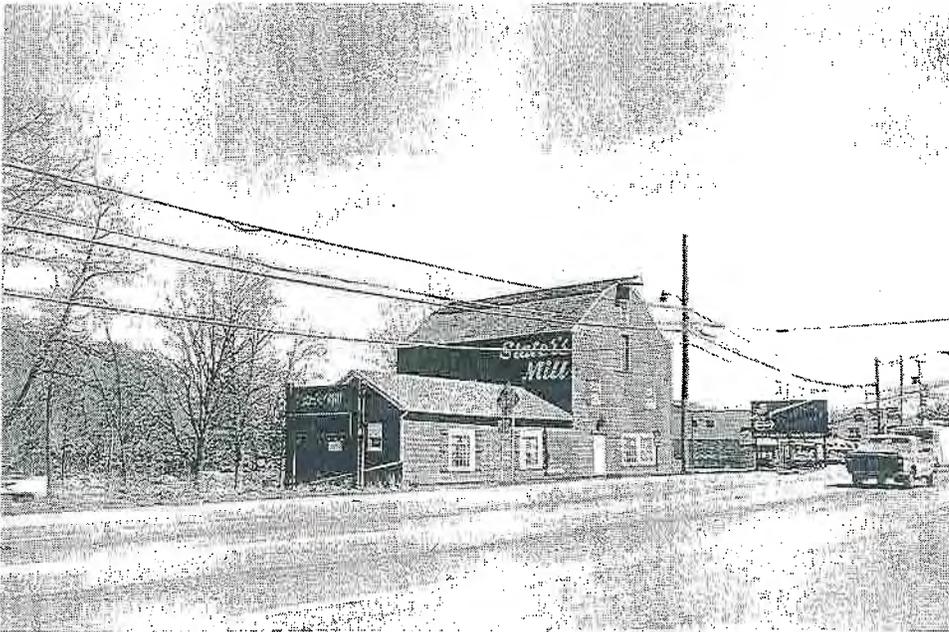
PHOTO Negative File No. A7:30

Integrity has been comprised with new wood siding and fake shutters, some new sash. Siting and landscaping are poor.

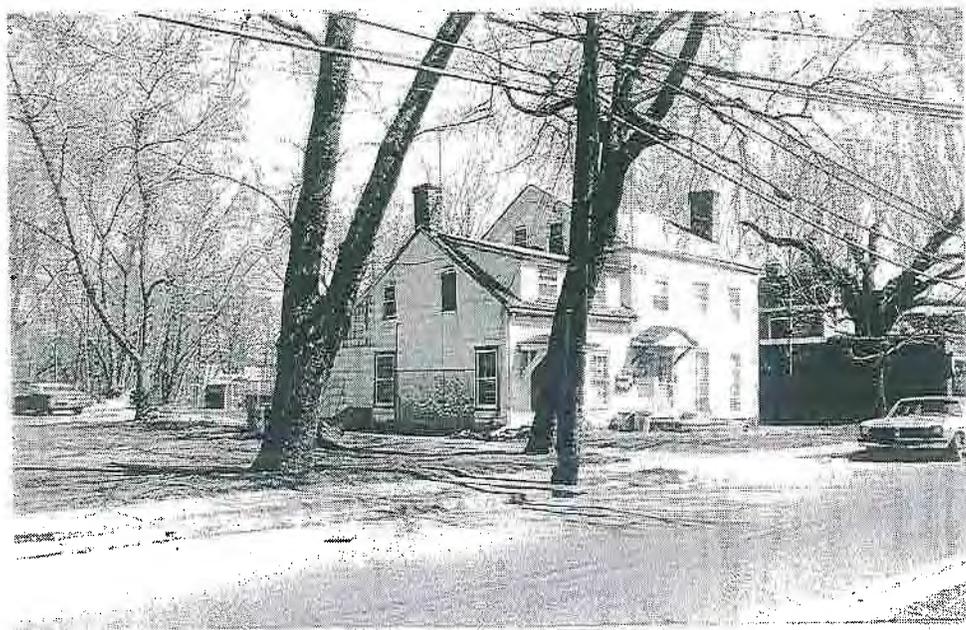
Negative File No. A7: 25

Construction Date: Probably mid-to-late-18th century
Source of Date: Stylistic evidence
Architect: Builder:
Style: Vernacular Form/Plan Type: Block-and-wing
Number of Stories: 1 1/2 and 2 1/2
Foundation: Cement and rubblestone
Exterior Wall Fabric: Asbestos shingle
Fenestration: Some 6/6 sash remain. Most windows have been altered.
Roof/Chimneys: Asphalt gables with interior brick end chimneys.

Small wing has large exposed brick fireback suggesting early construction date, two-bay facade, broad gable end, and low-to-the-ground massing. Larger wing has gable-end returns and french windows on facade. Entry altered with separate side-by-side doors.

Sited within 12 feet of road.

Site is degraded by proximity of intensively-used Main Street/arterial.

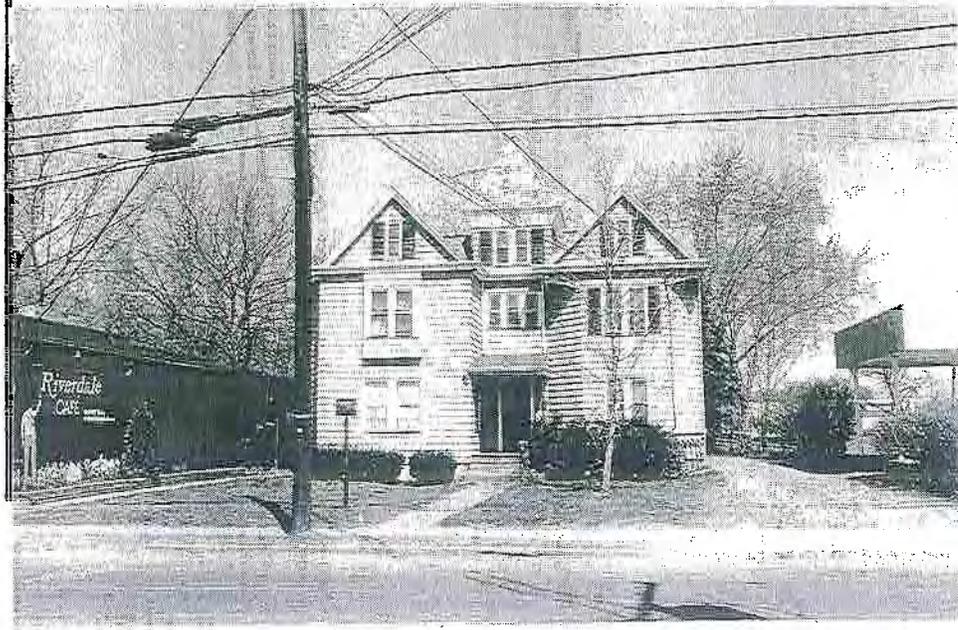
Negative File No. A7:25

Construction Date: Between 1868-1887 Source of Date:
Architect: Builder:
Style: Eclectic Victorian Form/Plan Type: Double-pile with centered entry
Number of Stories: 2 1/2
Foundation: Cemented
Exterior Wall Fabric: Synthetic siding
Fenestration: 1/1, multi pane/1, modern 6/6
Roof/Chimneys: Slate gables and pyramidal tower roof

Additional Architectural Description:
Two gabled projecting bays frame tower. Appears to have been stripped of porch.

Probably an impressive example of late Victorian eclecticism in its day, this house is sadly altered. It represents part of Riverdale's modest growth during the last quarter of the 19th century.

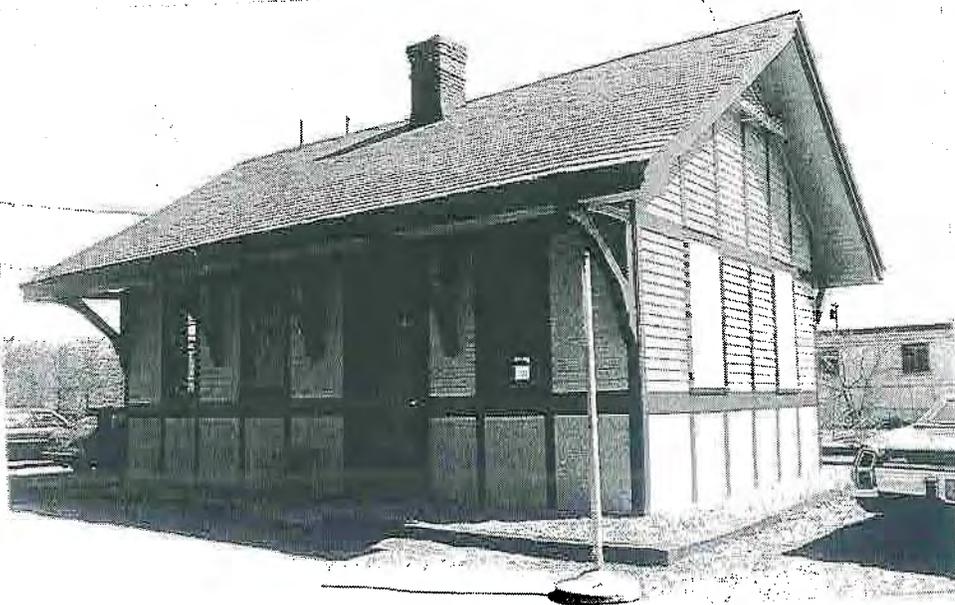
Negative File No. A7:27

Roof/Chimneys: Projecting gable supported by large knee brace on stick brackets

The clapboard and vertical-board sheathing is overlaid with a pattern of vertical and horizontal boards in typical Stick-style fashion. Most of the interior is intact, with original room arrangement, ticket counter and board-sheathed walls.

The New York and Greenwood Lake Railway reached Pompton about 1875. A station was built here in the 1880's but burned subsequently. It is unclear if the existing building was rebuilt after a partial fire or replaced entirely. Comparison with Pequannock station illustrates variations of Stick style railroad architecture.

Recent restoration has saved station from deterioration.
* Station is eligible in conjunction with Pequannock and Lincoln Park stations as examples of rare surviving 19th century wooden stations in Morris County.

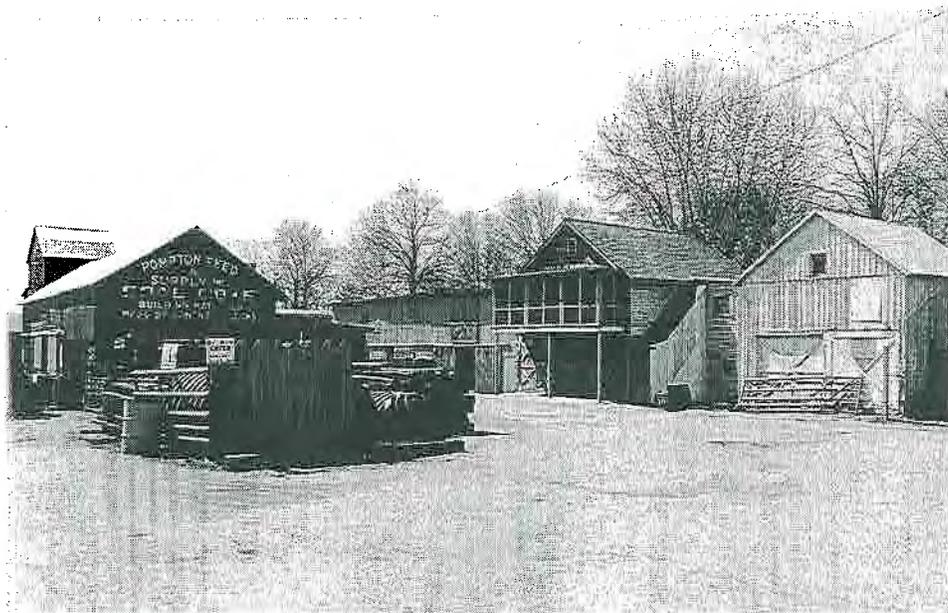
PHOTO A7:28
Pompton Feed & Supply Co., behind railroad station.

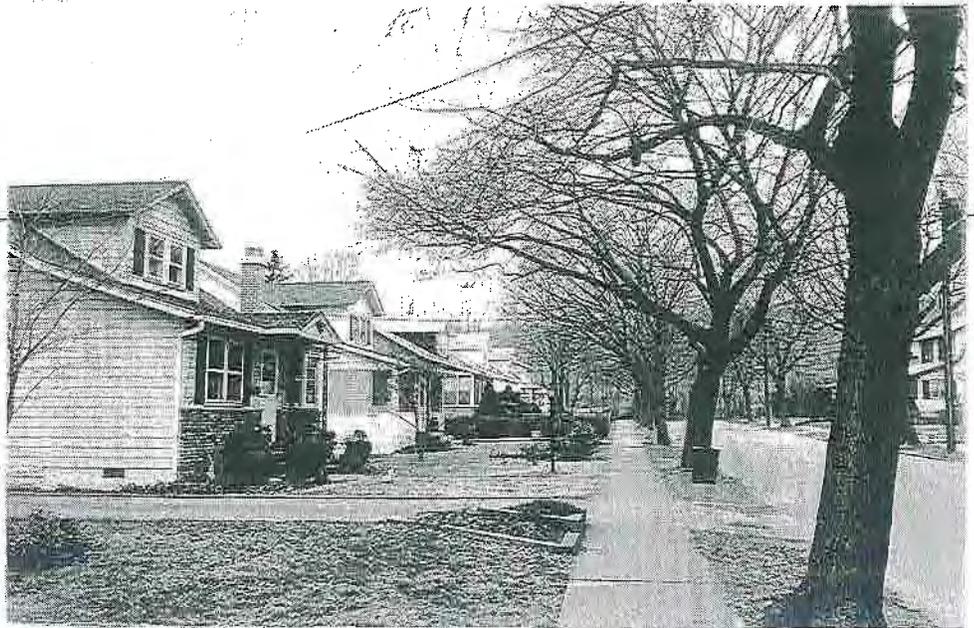
MAP:
SLIDES /Photos A8:8
REFERENCES:

This street is comprised of an unusually uniform and repetitive series of houses, all built in one of two related styles; a true bungalow of the simplest type, (18 houses), and a slightly larger house with vaguely Dutch Colonial lines (7 houses) due to its mock gambrel roof. The houses are very closely sited with a uniform setback and side yards. Only a few houses retain their original shiplap siding. Most have been covered with synthetic siding of some variety. The original foundations are rockfaced cement block. Many of the houses originally had small single-car garages, some of which survive. For most of its length, the street is tree-lined.

These are almost certainly prefabricated houses of the kind sold by Sears and other companies, shipped to the site by rail. The development suggests some particular associative history relative to a speculative venture or worker housing, but that history has not yet been uncovered. One Sears house model that closely resembles these Bungalows first appeared in 1925, a likely date for this street.

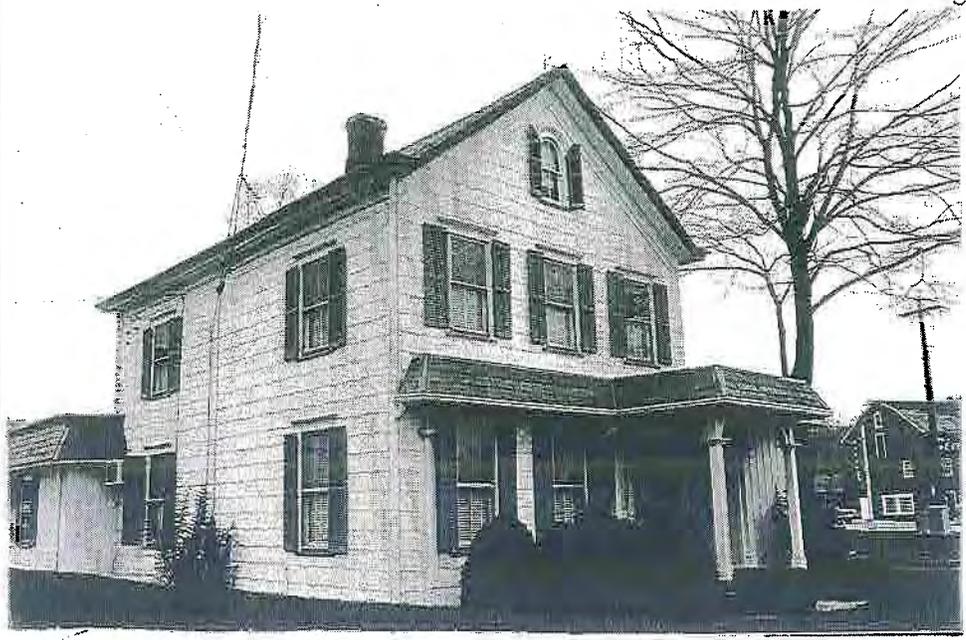
Negative File No. A8-9

Roof/Chimneys: Patterned slate cross gable with projecting eaves and molded frieze.

Additional Architectural Description:
Original porch mostly removed.

Corner location opposite historic Slater's Mill. Slate-roof privy survives.
