## PRESERVATION PLAN

## GLENBURN

BOROUGH OF RIVERDALE, NJ

**H M R** ARCHITECTS

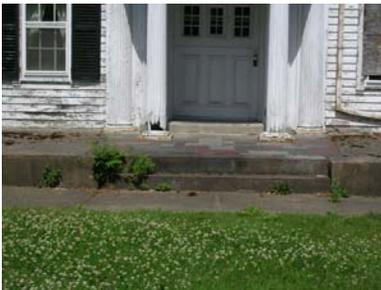
Photo 2 Concrete and flagstone entrance

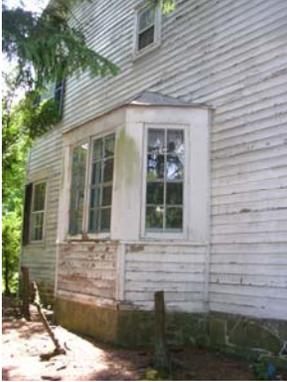
Photo 11 E103 has original decorative head and bracketed sill

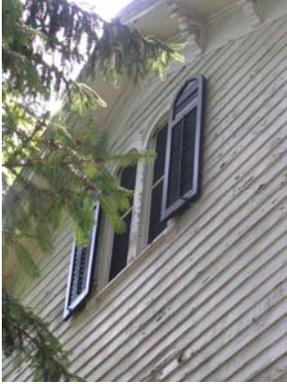
Photo 14 Paired casement windows, E301

Paired one-over-one casement with rectangular-light storms but rounded sash behind. Both shutters remain. They are arched. Same bracketed sill detail found throughout.

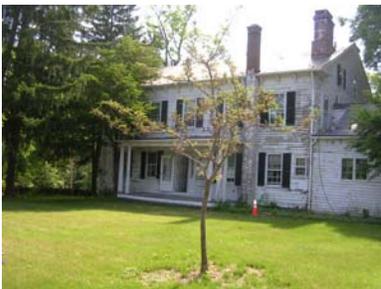
Photo 16 The north elevation of Glenburn

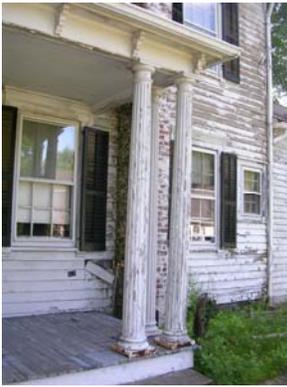
Photo 18 Three fluted columns of the north porch

Porch has three fluted columns at each of the front corners with bracketed cornice and asphalt roof. One concrete step up then wood.

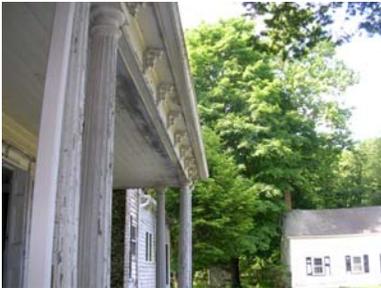
Photo 19 The bracketed cornice of the porch matches the cornice of the main block of the house

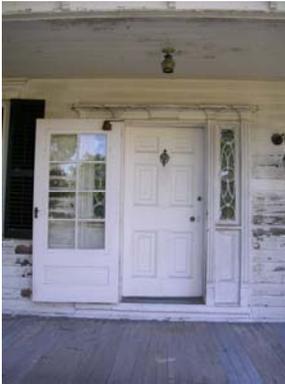
Photo 20 The six-panel door N1 appears to be original

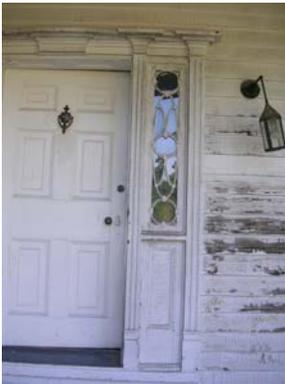
Photo 21 The sidelights are also original

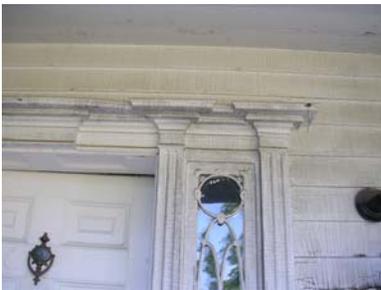
Photo 21 The elaborate doors surround is an important character-defining feature and is original

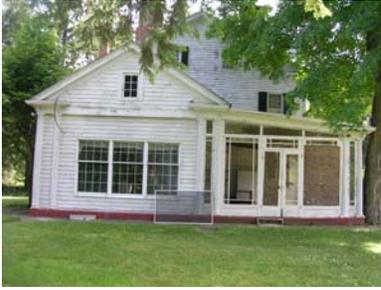
Photo 25 West elevation

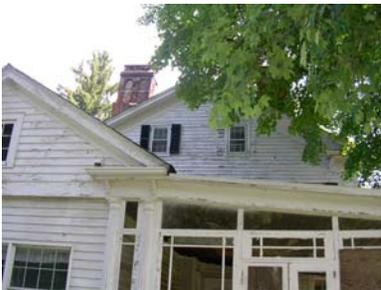
Addition has same paired columns as north porch of the main block. The porch to the south of the addition has the same paired columns and cornice returns with brackets. The addition and porch was heavily modified in 1949.

Photo 27 The porch has the same paired columns as the north porch. The cornice of the main block does not have the brackets found throughout the rest of the house.

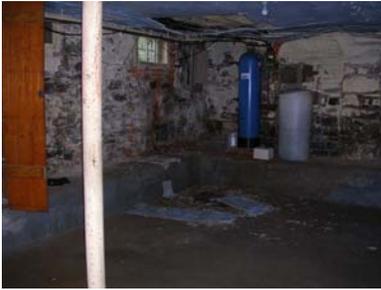
Photo 28 Room 001

Concrete floor, parged stone walls, plaster ceiling with exposed areas that show hand-hewn floor framing above. The framing of the west end, hall above, runs east west. The framing of the east end runs north south from exterior walls to a broad center girder. The framing appears to be white washed, meaning this room was originally a used space. The flooring above is tongue and groove.

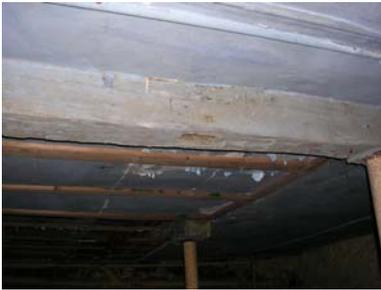
Photo 29 The original hand-hewn framing is heavier than the framing found in Room 002

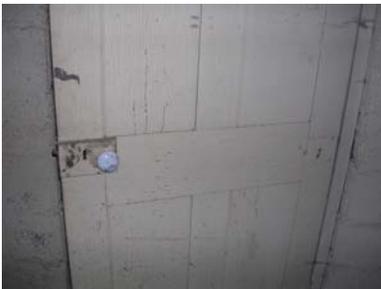
Photo 30 Door into Room 002 may date to ca. 1868

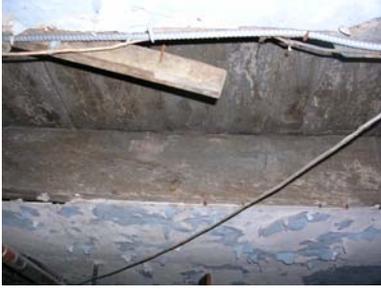
Photo 31 The framing in Room 002 is also hand-hewn but less substantial than the original

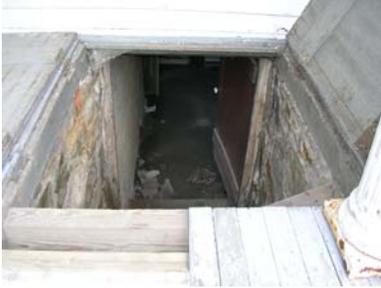
Photo 32 Exterior entrance to the basement is original

At the northern end, there is a beaded board door with box lock and porcelain knob. Beyond this is a set of stairs, stone on brick with stone cheek walls, that leads to the exterior and a bulkhead door. This basement access is likely original.

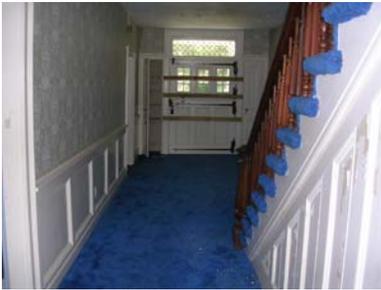
Photo 33 The first floor stair hall

Generally sound but with areas of mold, especially at the ceiling. The wallpaper is peeling.

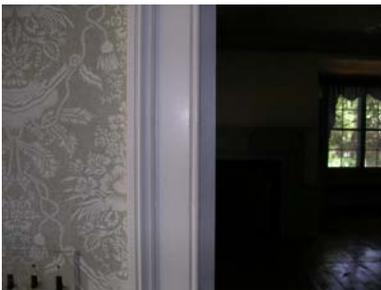
Photo 34 The trim in the stair hall dates to the 20<sup>th</sup> century

Doors casings all the same, 5" with a simple back band molding. This trim dates to the twentieth century.

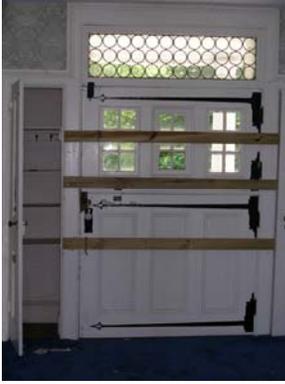
Photo 35 Door S1 is a Colonial Revival upgrade

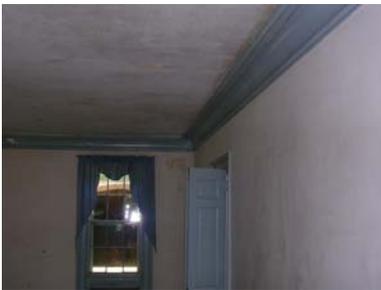
Photo 39 There is a decorative cornice in the parlor. This is a 20<sup>th</sup> century upgrade

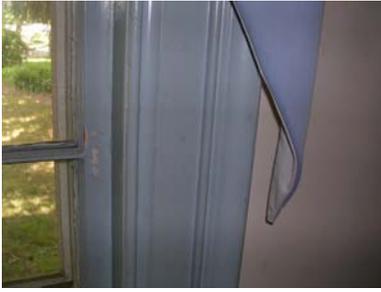
Photo 40 The window trim in the parlor is original as are the north and south sash

Wood trim at door and window casings are unique in this room. They are 6" with a large inner bead. The casings could be original. 10" wood baseboard and cove molding at ceiling. Because the cornice and baseboard are continuous without scarring from a partition, they were added in the twentieth century when this room became a single large space.

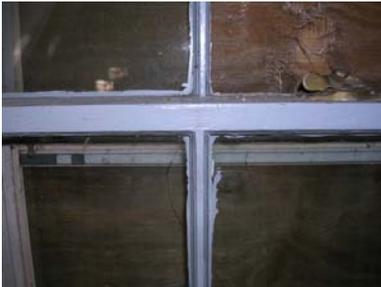
Photo 41 The original muntin profile is deep and thin

2-10"x 5'-1" six-over-six with pegged sash and a deep thin muntin measuring 1/4" x 1 1/4". These windows are original. Heaters have been added where a window panel was originally. N103 has several broken lights.

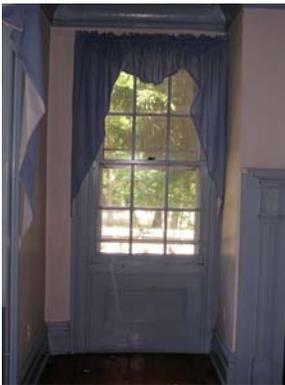
Photo 42 The eastern sash were replaced during the Colonial Revival upgrades. They are not pegged and their muntins have a different profile than the 19<sup>th</sup> century muntins.

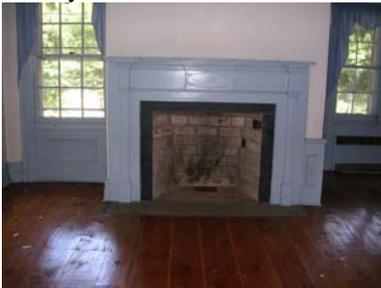
Photo 43 Fireplace in the parlor

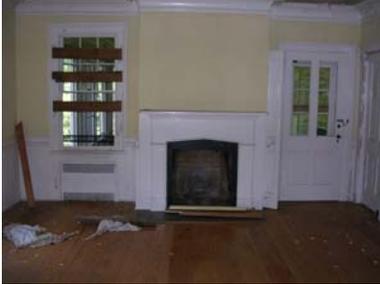
Photo 44 Rear parlor

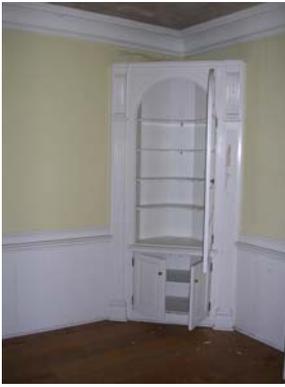
Photo 45 The corner cabinet in the rear parlor likely dates to the 20<sup>th</sup> century

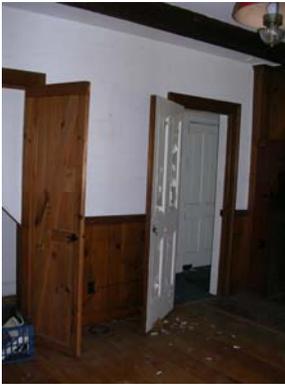
Photo 47 Doors in the den

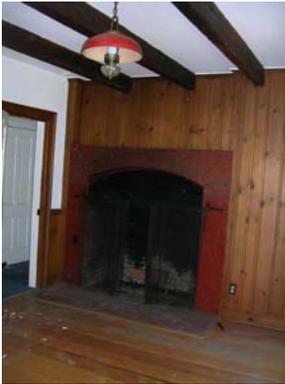
Photo 48 The large simulated cooking fireplace of the den

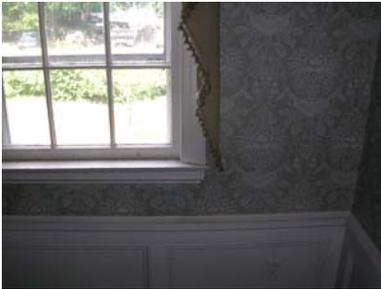
Photo 49 The window trim is original; the wainscot is from the Colonial Revival upgrades

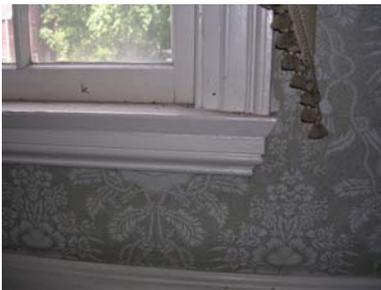
The window trim is different. It is 4 1/2" with a more elaborate back band molding. This trim appears to be older and could be original, dating to the nineteenth century.

Photo 50 The window trim at the stair landing appears to be original

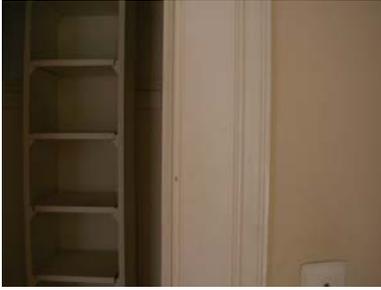
Photo 51 Most of the trim on the second floor dates to the Colonial Revival

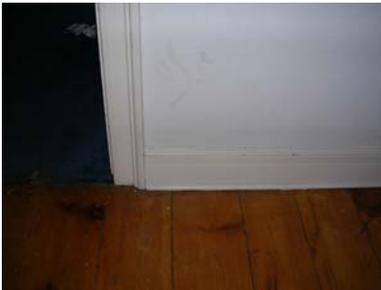
The baseboard matches the second floor hall baseboard, 8 1/2" with a plain base, recess and then top molding. It can be found on all walls, including within the closet. This means it was added after the closets and bathrooms were installed.

Photo 53 The baseboard throughout the second floor dates to the 20<sup>th</sup> century upgrades

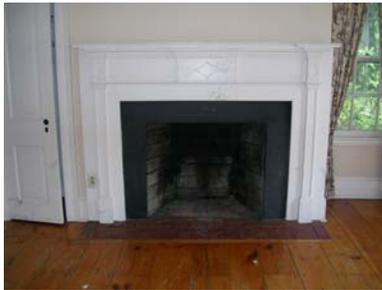
Brick fire back and hearth, tile surround with wood mantel with diamond motif. The fireplace is original; the detailing is probably from the Colonial Revival upgrades.

Photo 55 Fireplace in Room 204

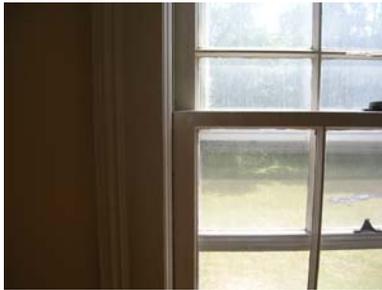
Photo 56 The woodwork in Room 204 is newer; it dates to the late 20<sup>th</sup> century

The south window and door trim in this room is unique and appears to be newer than that found throughout the house. It is 4 ½-inch stock trim dating to the second half of the twentieth century.

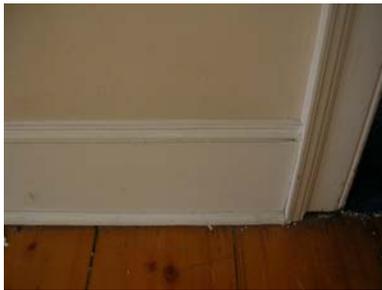
Photo 57 The baseboard is also newer

The baseboard is also unique to this room. It is 9” with a plain base and simple cap molding. It too appears to be late-twentieth century stock molding.

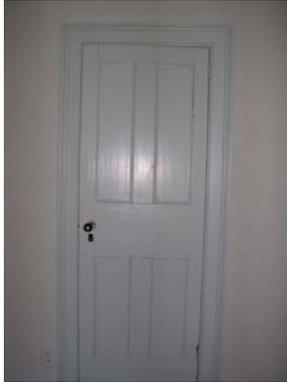
Photo 61 Original ca. 1868 door

Door similar to that found in the hall with four recessed panels on the outside and beaded flush panels on the inside with box lock. The panel mold profile is slightly smaller than the other profiles. This could be an original door in its original location to an original closet.

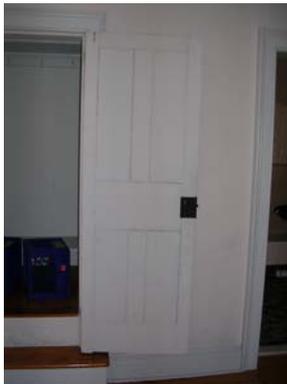
Photo 62 The panel mold profile is slightly smaller than the other profiles and is likely original

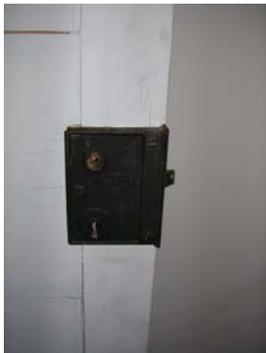
Photo 63 Original hardware in Room 209

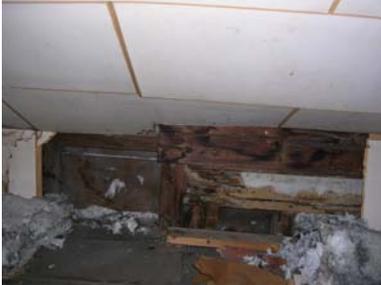
Photo 64 Pulling off the modern finishes proves that the building was constructed in two phases. The structural systems are not tied together

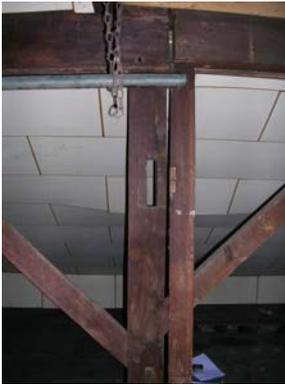
Photo 65 The dividing line between the two sections

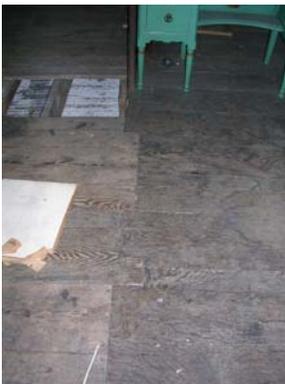
While some of the framing is exposed, most is encased in Homosote. The floor is the original wide flooring. Investigations into the northern wall confirmed that the building was built in two sections.

Photo 66 The line in the floor delineates the two phases of construction

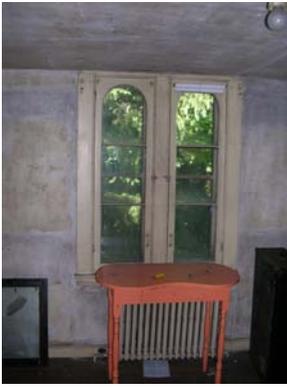
Within the center room of the eastern end, there is a pair of three-light casement windows that are arched. They date to the nineteenth century.

Photo 67 The arched windows of the attic date to the later 19<sup>th</sup> century

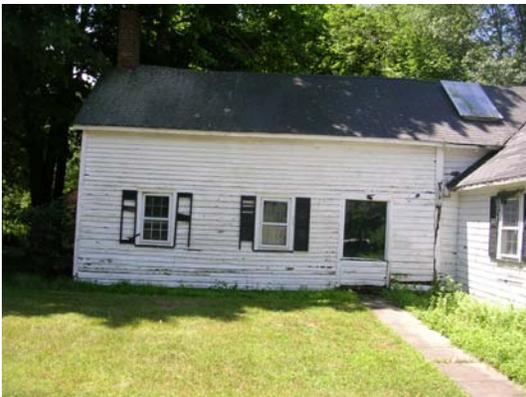
Photo 68 This section of the frame outbuilding could be a summer kitchen or may be the original building on the site. It dates to at least the 19<sup>th</sup> century.

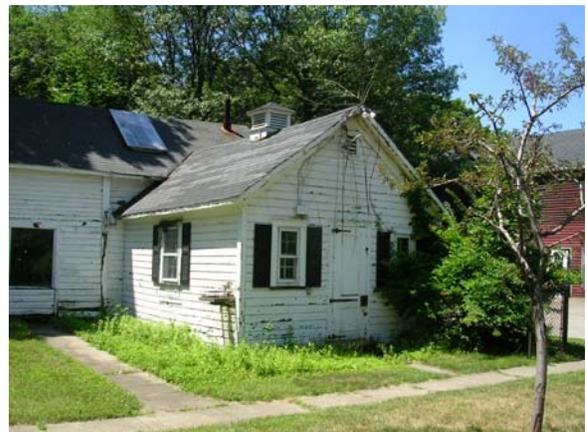
Photo 69 This section of the frame outbuilding has a stone foundation. This could be an older structure.

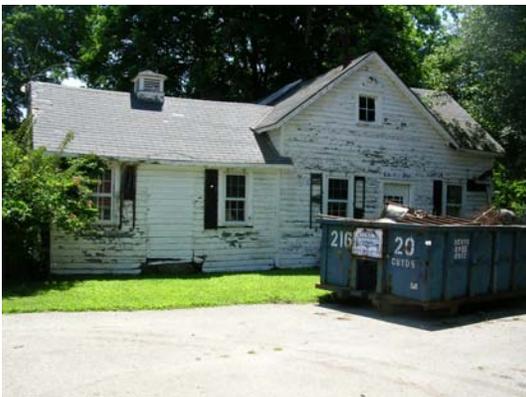
Photo 70 This section of the frame outbuilding is probably later

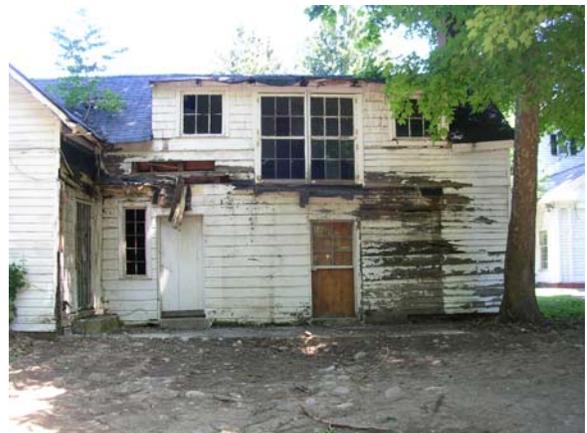
Photo 71 The rear of the frame outbuilding. A large dormer was added

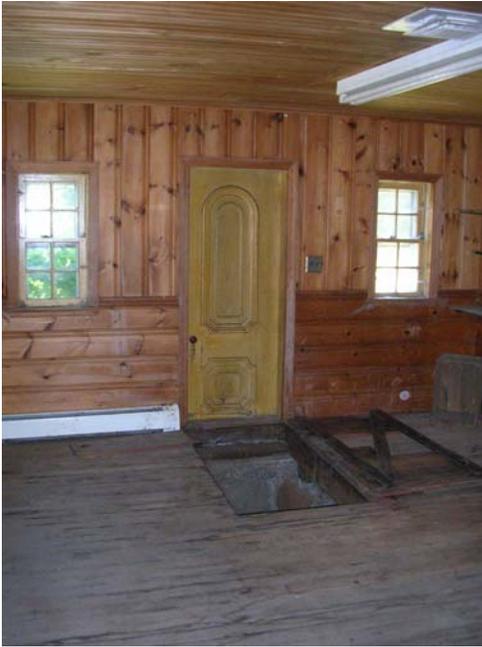
Photo 72 The interior of the frame outbuilding is a mix of old and new. The door dates to the 19<sup>th</sup> century

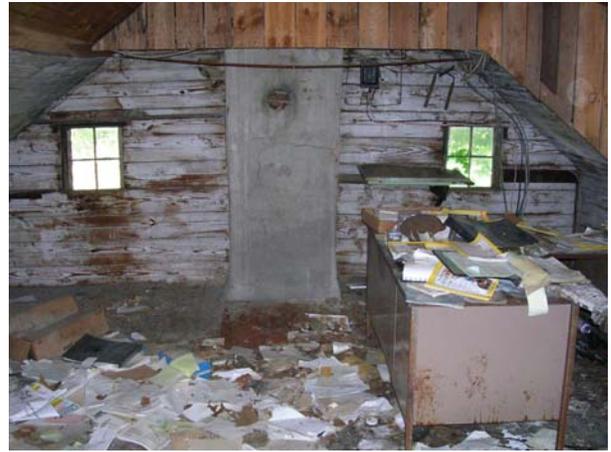
Photo 73 The second story of the frame outbuilding is a mix of old a new

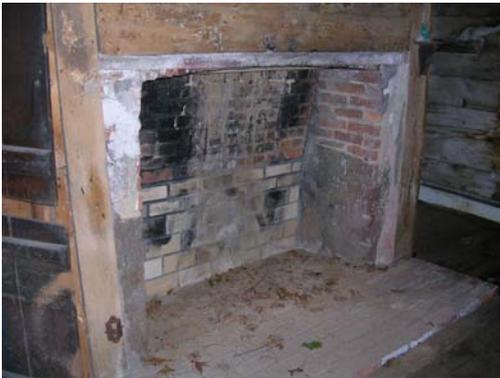
Photo 74 Within the frame outbuilding, there is a large cooking fireplace. It may be historic but most of its features are later

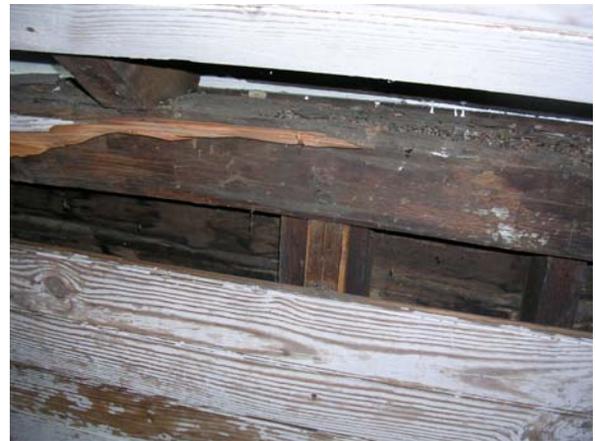
Photo 75 On the second story, behind the newer finishes, the original pegged and hand-hewn framing is visible

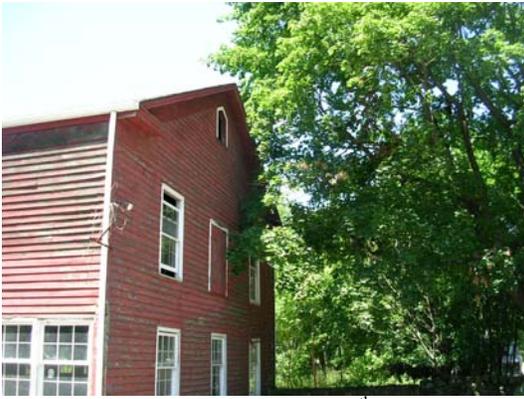
Photo 77 The barn dates to the 19<sup>th</sup> century

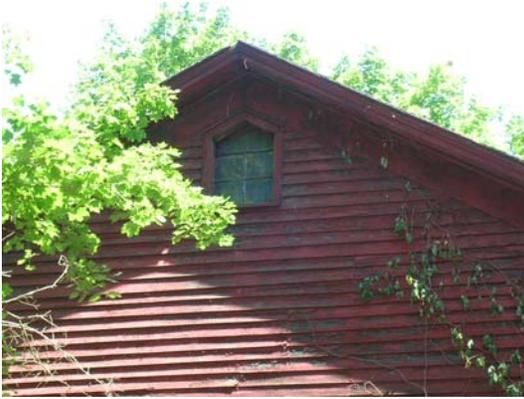
Photo 79 The upper gable end of the barn

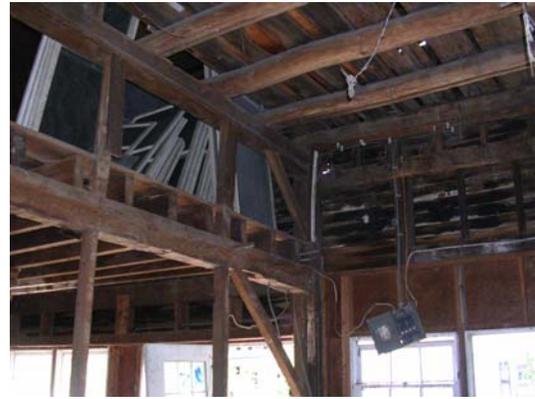
Photo 80 The interior of the barn retains most of its original framing
